SEALED ENVIRONMENT

Climate Control of Historic House Museums

Submission for HODI Award for Built heritage Conservation

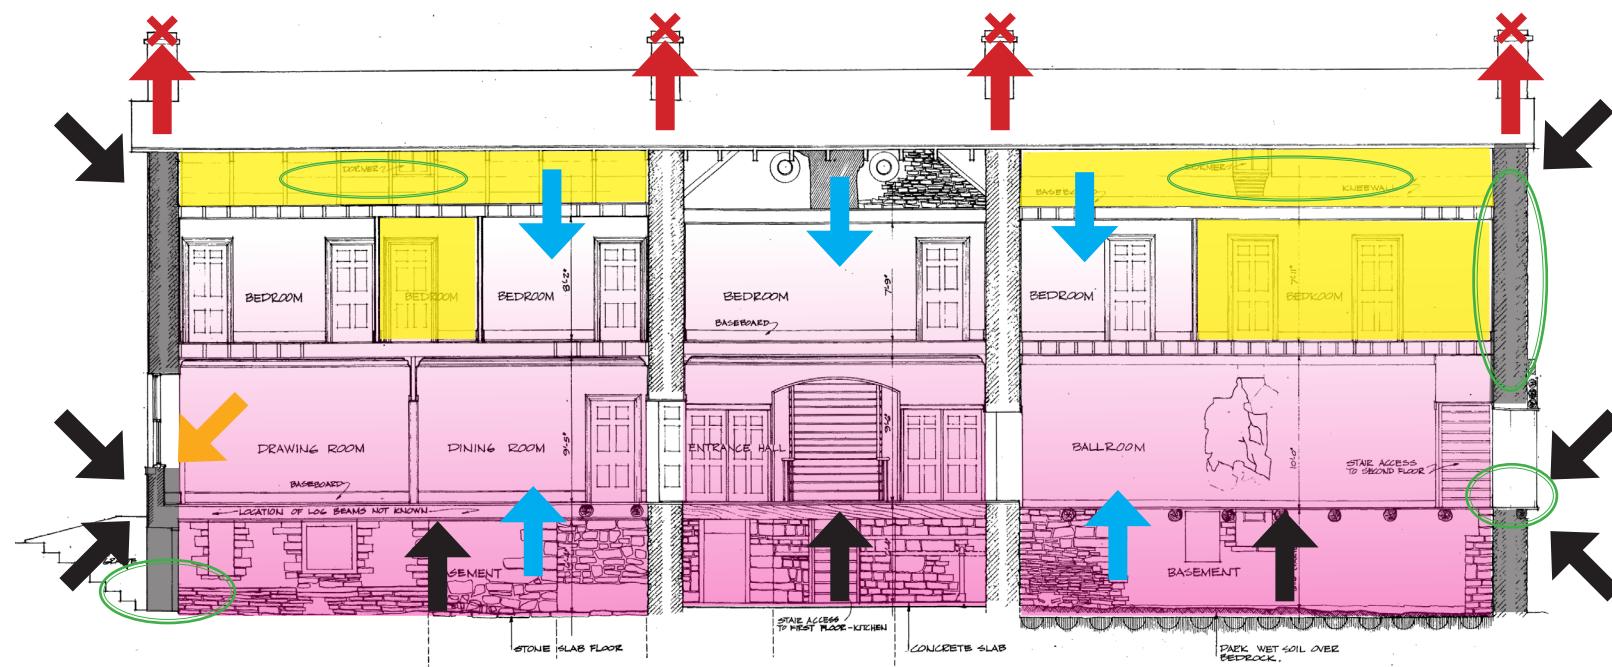
CONDITION ASSESSMENT OF THE HOUSE MUSEUM

High risk ↑
↓ Low risk

- 1 Uncontrolled moisture
- 2 High relative humidity
- 3 Inappropriate artifact storage
- 4 Poor ventilation
- 5 Issues with climate control system
- 6 Pest infestation
- 7 Condensation on windows

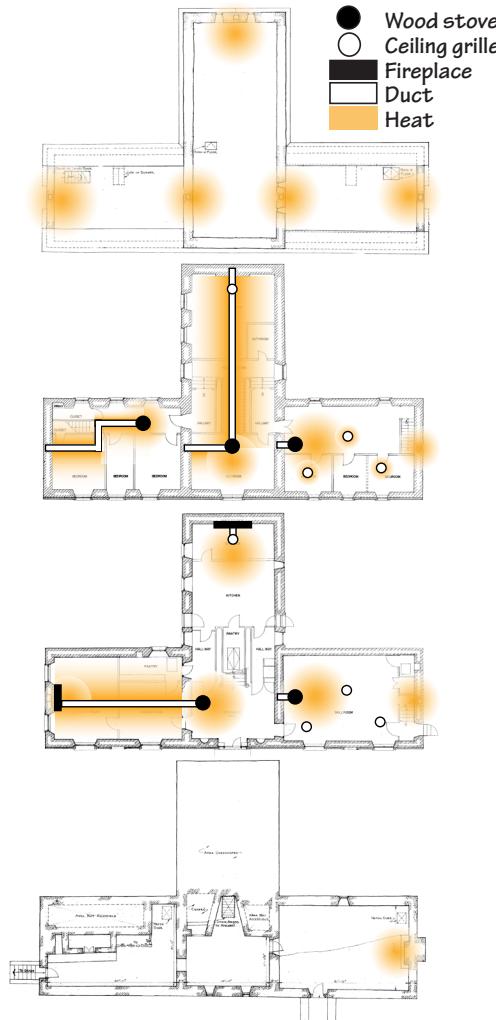
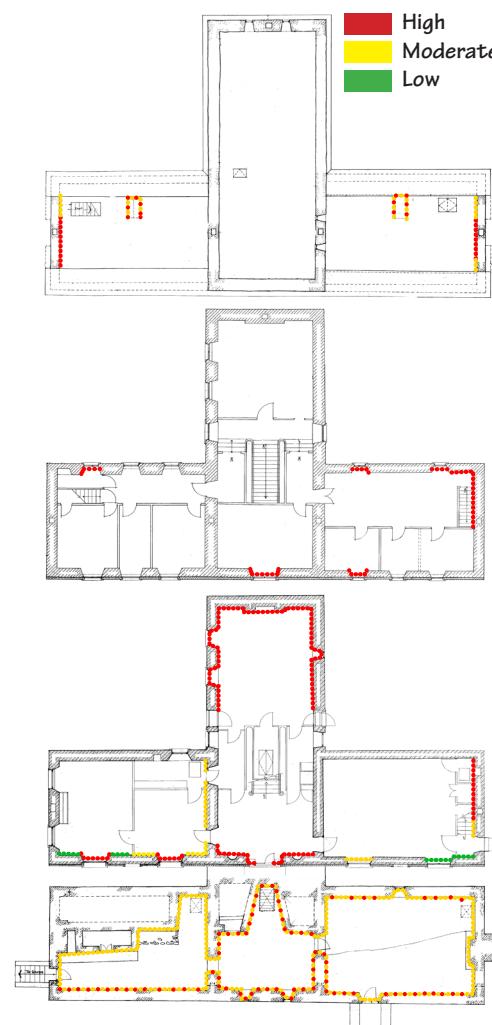
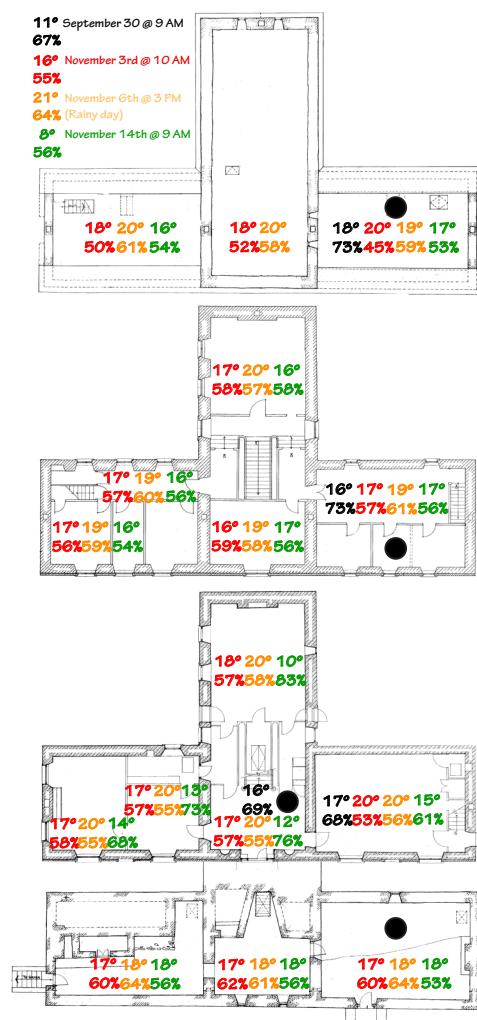
ENVIRONMENTAL STUDY

A single-season monitoring program was undertaken with a weather station to measure the temperature and relative humidity (RH) inside the house museum. The data collection started in September and was performed once a month for four months in the morning at various rooms of the house. All three levels of the building had consistently high RH levels, predominantly over 50% in all rooms. The basement had the highest RH levels, never going below 60% likely due to damp foundation walls. The high level of RH can easily facilitate the growth of mold and other fungi on organic materials such as wood, paint, and paper. The outstanding challenge for most house museums is to find an appropriate level of RH for the best preservation of the content as well as the historic structure. RH is not an agent of deterioration, but an improper level can threaten the historic structure and the collection.

Additionally, a relatively high level of RH fluctuations was observed within a short period of time during the monitoring season. For example, the RH in the west wing's attic space fluctuated between 45% and 73% during the four-month observation period. A rapid change in RH causes the moisture contents of organic materials to change sharply, which in turn causes their size to alter, resulting in cracking of their surfaces. Currently, the east and west wings' attics are used for artifact storage. These attic spaces are poorly ventilated with high temperatures in cooling seasons and low temperatures in heating seasons. The temperature ranges result in high RH fluctuations that can be threatening to the stored historic artifacts.

Mitigating the basement's moisture problems will automatically reduce the high RH in the building. However, a suitable monitoring system with temperature and RH sensors should be installed inside the exhibition rooms to collect a full year of data to ensure safe levels of RH. The existing climate control system should be equipped with a humidistat-controlled digital device instead of a thermostat. It is generally acknowledged that controlling the RH is more effective than controlling the temperature. When humidity rises above a certain level, such as 50% during the heating season, the heating system is activated to heat the room, which results in a decrease in the RH level. Also, the ventilation system should be controlled by humidity or dew point sensors so that it operates only when the air outside is dryer than inside. A modified use of conventional climate control systems can assist in keeping the winter and summer humidity at preferred levels.

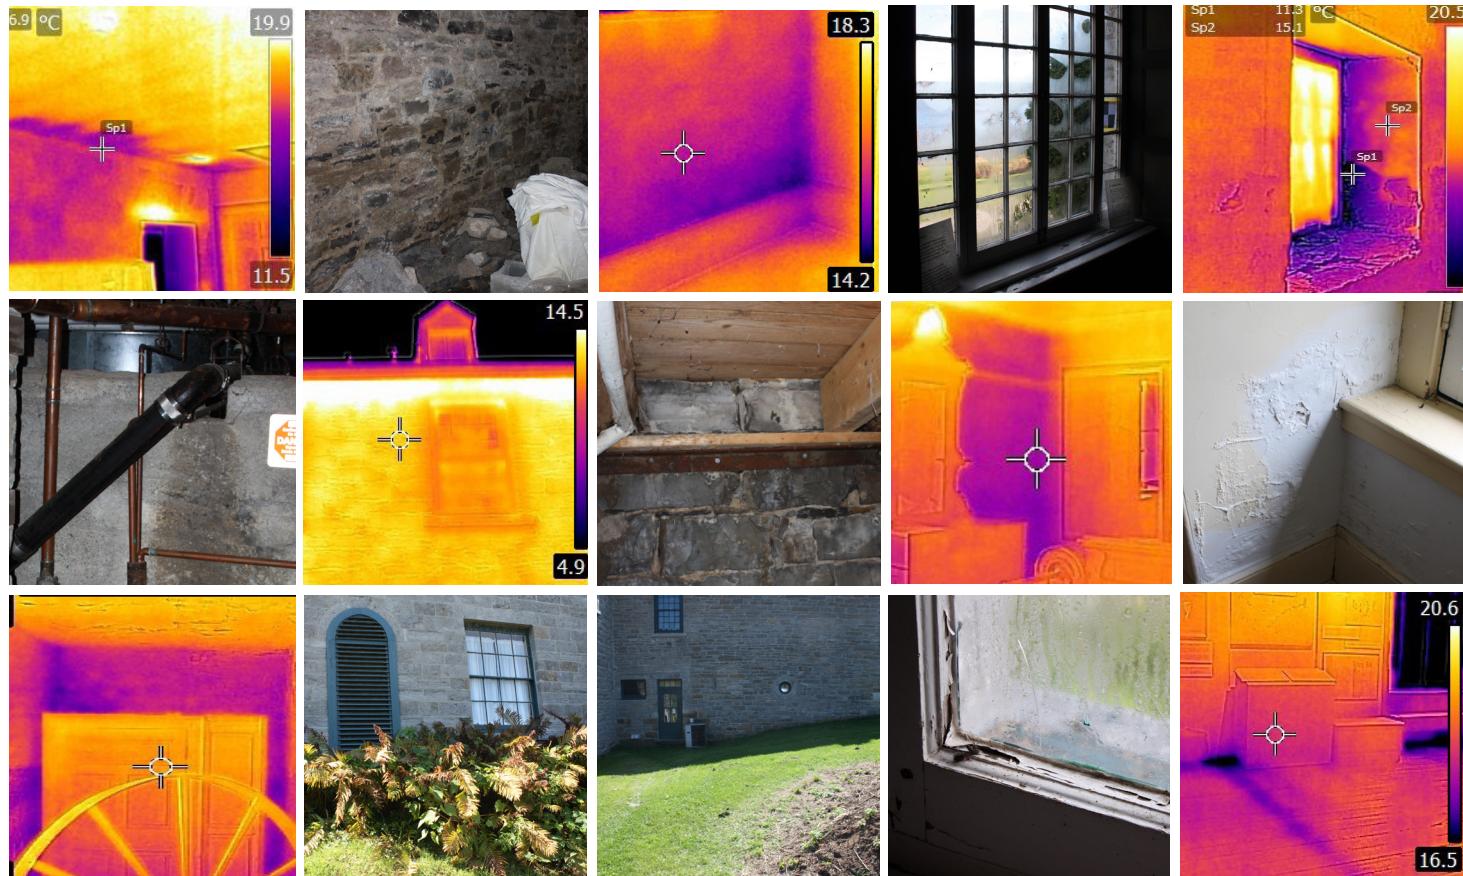
PERFORMANCE FAILURES

In order to stabilize the indoor environment in this house museum, one of the first steps is to manage the moisture levels. Several entries of liquid water were noticed throughout the building envelope. And it was determined that many locations had high moisture levels, which can be a results of various factors.

There are currently no gutters or downspout systems for handling surface rain run-off. Managing the rainwater is one of the most important measures in reducing the unwanted moisture for any historic building. Uncontrolled rainwater saturates the soil around the building and eventually wets the base of the building. The moisture will seep through any cracks in the foundation walls, leading to a damp basement that can increase the level of relative humidity in the entire building. The slopes and grading around the foundation walls also contribute to the high moisture levels in the basement. The ground slopes downward at the south elevation and directs rain and ground-water toward the building, leading to damp masonry walls in the basement and the south wing's central kitchen at grade. Additionally, rising damp appears at the base of the foundation walls and up to about one-and-a-half metres above ground level in the south wing's kitchen walls. The visual evidence of the rising damp is a band of discolouration or physical damage on the surface of internal walls.

Deteriorated mortar joints were observed at the base of all exterior walls close to grade. Water and moisture penetrates thorough deteriorated mortar joints and saturates the masonry walls, leading to a reduction in the thermal performance of the walls. Also, sections of the walls have been repointed over the years with cement-based mortars, which restricts the breathability of the fabric

In terms of addressing some of the indicated issues, the highest priority climate control recommendation is to reduce the moisture problem at the source. Installing a roof water collection system with gutters and downspouts can help with directing the water to a storm water system with a perimeter drainage system at the subsurface level. The next necessary intervention is lowering and sloping the grades in a manner that will direct water away from the foundations, and help reduce the rising damp around the south side of the building. Also, vegetation close to the north wall must be trimmed or relocated away from the building to help with air circulation around the building. Furthermore, the air flow and ventilation should be increased in the basement and the kitchen, which is located on the south side, to dry the walls. Regular maintenance is required for early detection of any source of damage. Examining the masonry walls is an important part of the regular maintenance program. Decayed stones should be replaced with a matching unit. Also, any cement-based mortars should be removed and repointed with appropriate formulated mortars to increase breathability.
