# Official Residences of Canada

NATIONAL CAPITAL COMMISSION  
COMMISSION DE LA CAPITALE NATIONALE

2021 ASSET PORTFOLIO CONDITION REPORT

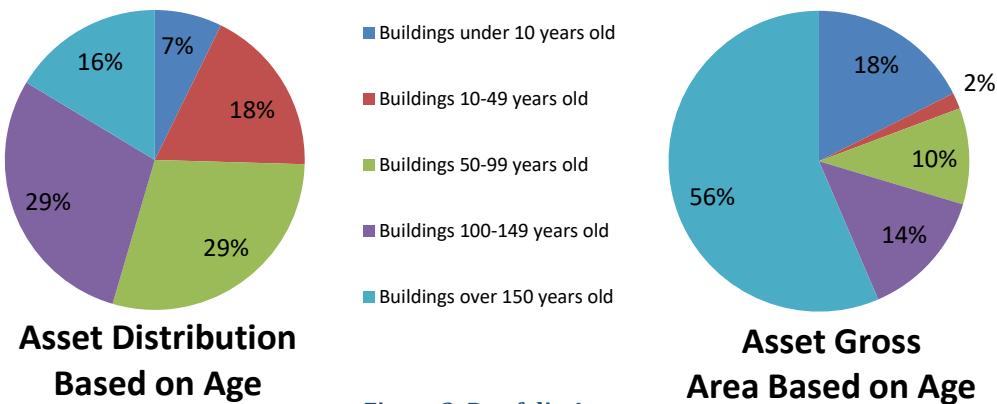
Figure 3: Portfolio Age

The main residences and the overwhelming majority of their ancillary buildings were built when different building codes and lower standards of health and safety requirements applied. Approximately 74% of the building portfolio is over 50 years old, with 16% older than Canada, which recently celebrated its 150<sup>th</sup> birthday in 2017.

As shown in Figure 3, 74% of the building portfolio is over 50 years old.

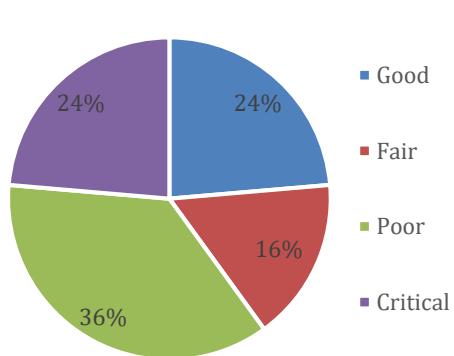
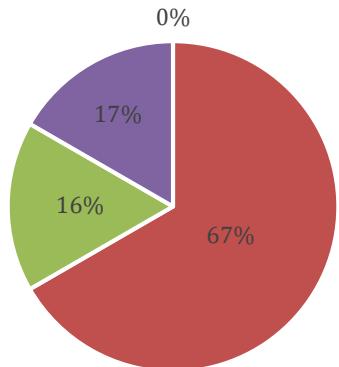
Figure 4: OR Portfolio FCI Assessment

Official Residences Portfolio  
FCI Based on No. of Buildings

Main Residences Only  
FCI Based on No. of Buildings

Figures 4 and 5 demonstrate that while the overall FCI for the Portfolio is “Poor” at 0.136, 61% of the Portfolio’s individual assets are identified as being in “Poor” to “Critical” condition. However, the vast majority of the assets are operationally safe. Of the main residences, Rideau Hall, Harrington Lake, Stornoway and 7 Rideau Gate are now all in “Fair” condition, with the Farm in “Poor” leaving only 24 Sussex “Critical”. Historical investments have been prioritized to repair building failures (roof leaks, plumbing, electrical, etc.), alleviate current health and safety concerns, comply with regulations and ensure critical building systems remain in operation.

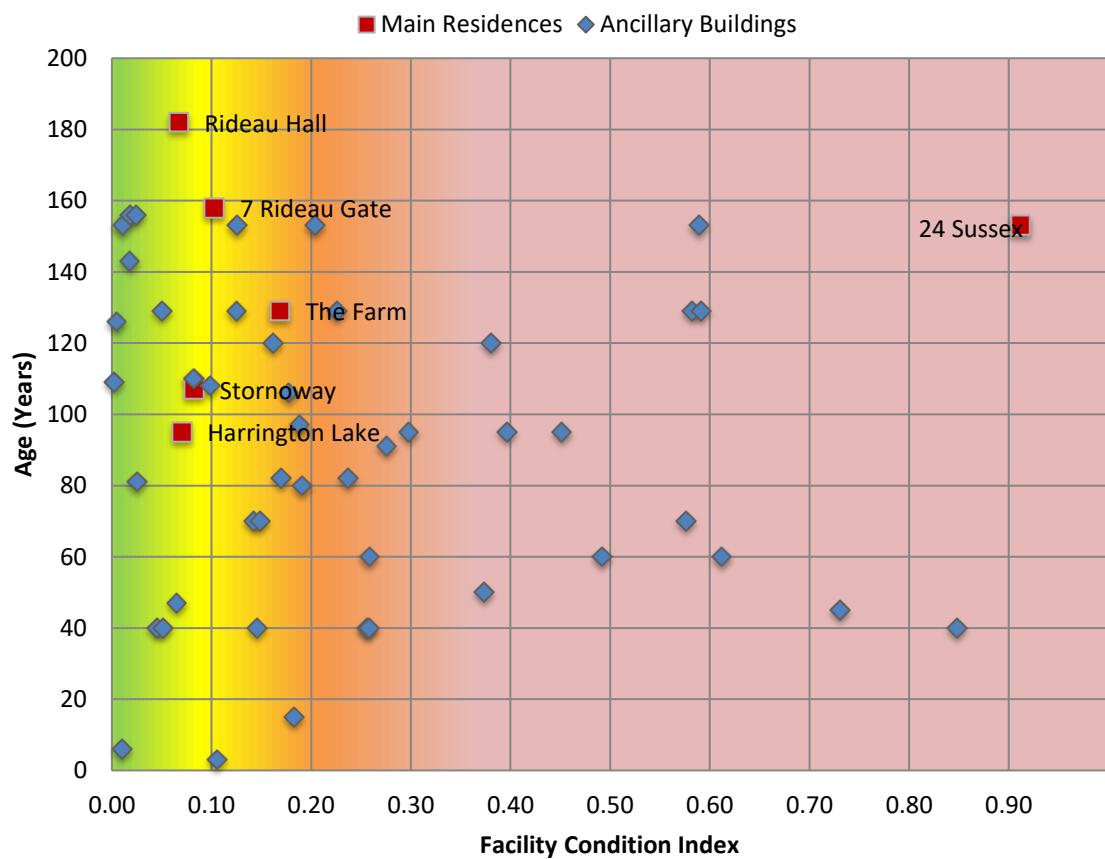
Figure 5: OR Portfolio Age/FCI Matrix

Official Residences Portfolio  
Age/Facility Condition Index Matrix

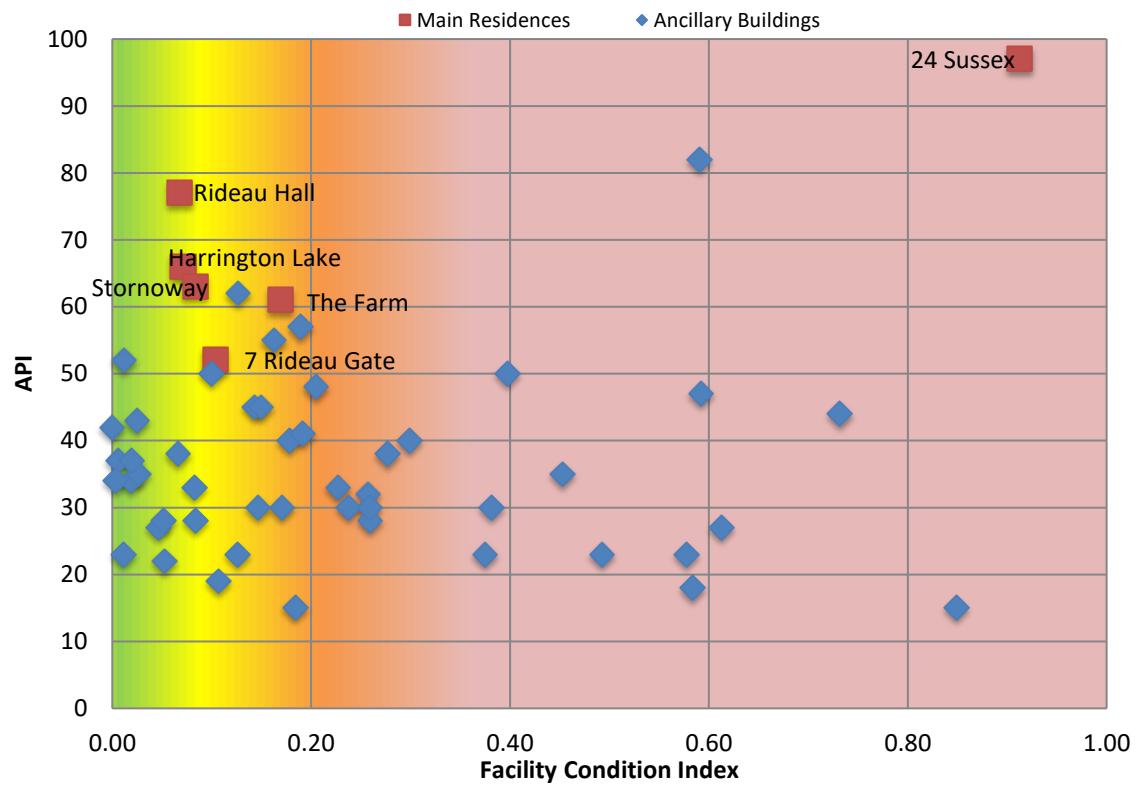
Figure 6: OR API/FCI Matrix

## ORB Portfolio API/Condition Matrix

Figure 6 demonstrates that 24 Sussex is in critical condition and a high priority.

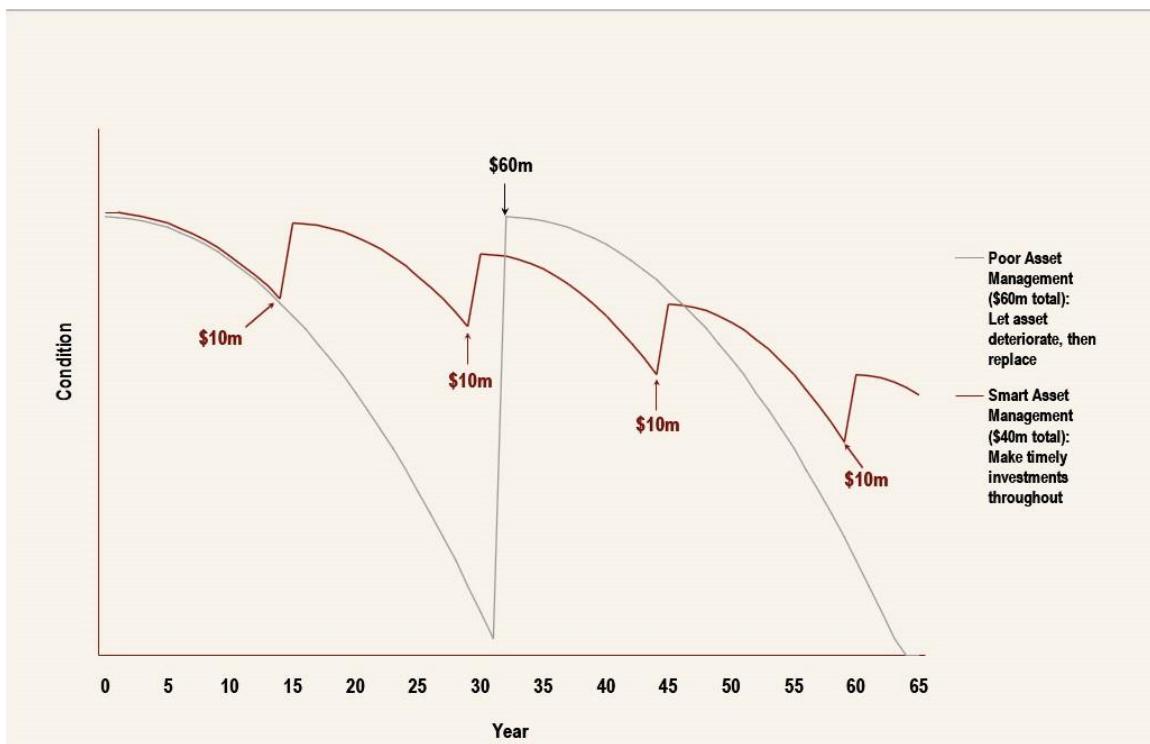
Figure 7: Small but Timely Renewal Investments Save Money (<https://files.ontario.ca/figure1-en-v2.jpg>)

For a building with a CRV of \$60M, regular investments of \$10M every 15 years, will maintain the asset in good condition. This amounts to a total of \$40M over the typical useful life of a built asset.

Much like what has happened to the Official Residences Portfolio, the long-term costs are much higher when the asset is allowed to completely deteriorate before investing the full replacement value of \$60M once, then again letting the asset completely deteriorate over the same amount of time.

Figure 7 shows how much a wise investment of regular maintenance and recapitalization will save taxpayers over time. Regular maintenance and recapitalization will result in a total savings of \$20M over the life of a typical real property asset, with a replacement value of \$60M.

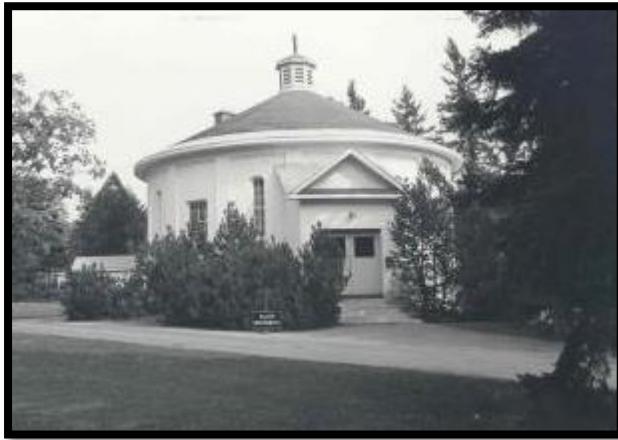
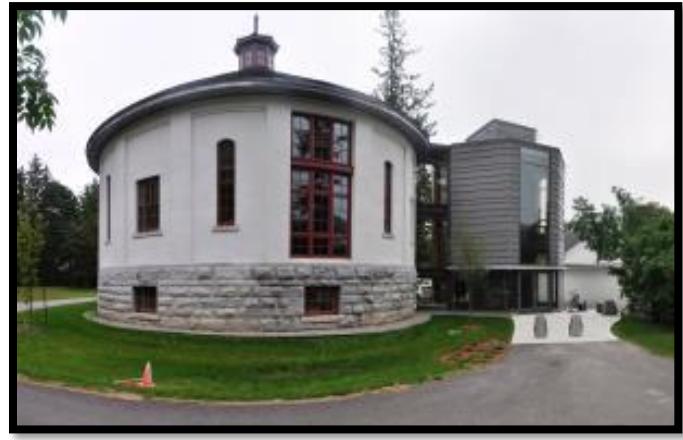
### ***3.1.2.5 The Dome Building***

Originally a “gasometer” built in 1877–78 to store manufactured coal gas to fuel light fixtures in the residence, it was rehabilitated in 2013. The rehabilitation included a three-floor elevator tower and extensive designated substances removal. It is currently used for OSGG administrative functions.
